Silicon Precipitate Nodule-Induced Failures of MOSFETs

M. Johnson and D. Pote
Motorola, Inc.
Northbrook, IL

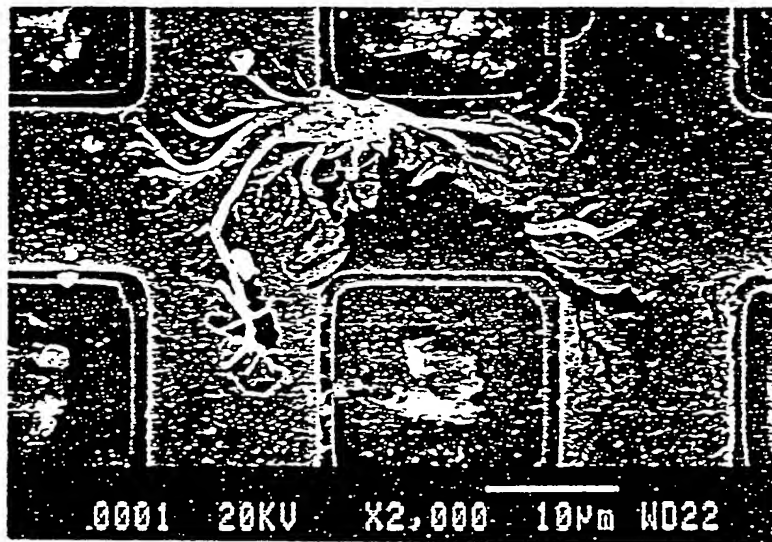
Figure 1: Unique pattern of fused polysilicon observed after removal of metallization and insulating oxide. (2000X)

Subsequent optical inspection identified an apparent electrical damage site under the wirebond. This damage was characterized by a central fused-site surrounded by multiple filaments (Figure 1). These filaments were dubbed "tentacles" or "roadkill" damage because of their appearance. SEM inspection of the same locations revealed surprisingly little

It is now believed that the filaments are the result of amplification of the damage at the original failure sites by the application of excess power during liquid crystal testing. A slightly higher level of power was necessary to counteract the obstructing heatsink effect of the relatively large wirebond. The heat generated at the damage site would initiate crystallization of the amorphous polysilicon depend-

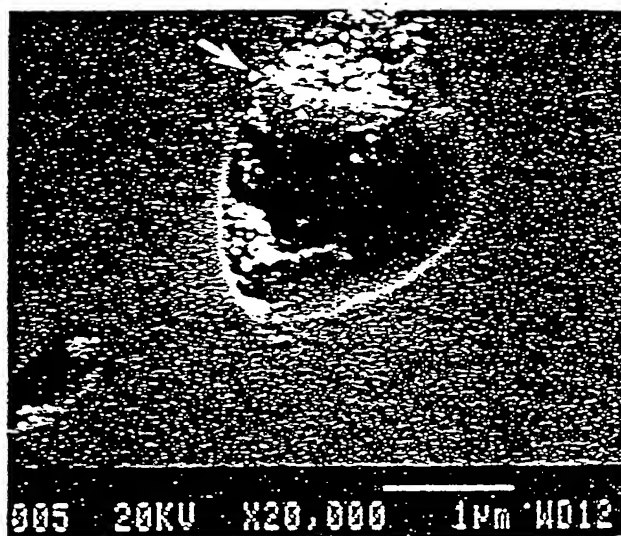
Figure 2: Small electrical damage site within chip.
(25000X)

Cross-sections of failures revealed that the filaments were confined to the polysilicon layer, except at the central nucleus. At the nucleus, melted silicon and aluminum were observed extending vertically through the dielectric layer. On several devices where the filamentation was minimal, there was limited evidence of melting at the nucleus site and a small section or chip of the dielectric was missing (figure 2).

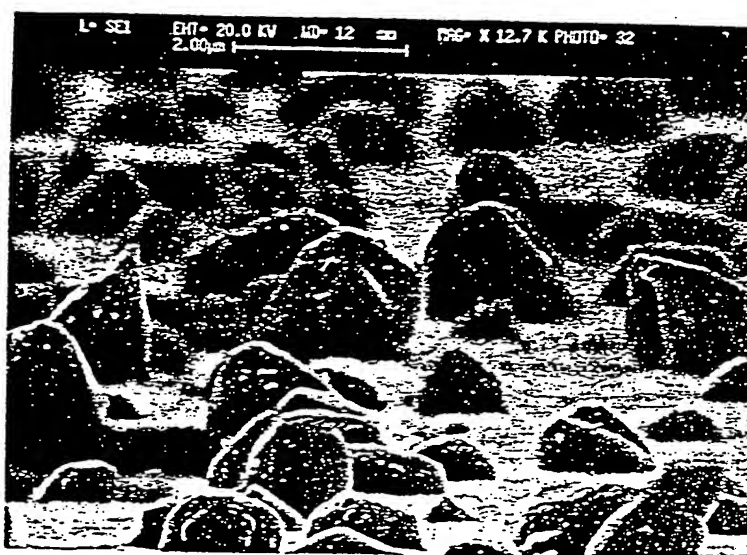
Figure 3: Silicon precipitates (nodules) viewed from side exhibit variety of shapes and sizes. (12700X)

shape. Although they appear roughly circular under high power microscopy (400X), they are actually polyhedral and exhibit a wide range of aspect ratios (Figure 3). Typical height/width ratios range from 0.3 to 1.8.

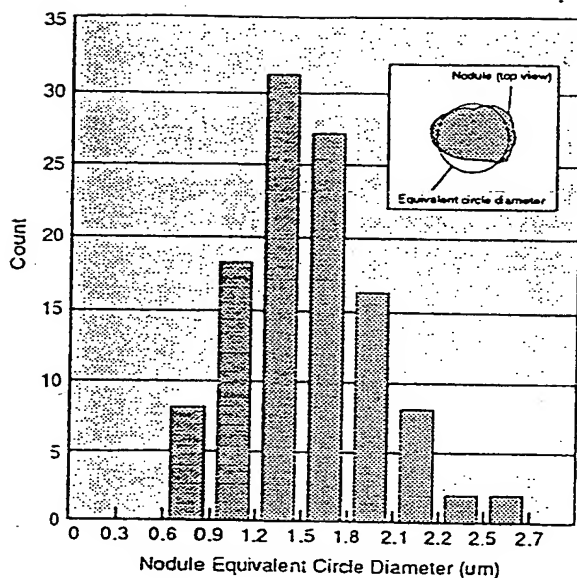
There were typically 50×10^3 to 100×10^3 nodules per square millimeter in the subject devices. In general, the nodule density -- the number of nodules per unit surface area -- was inversely proportionate to the average size of the nodules. That is, when the nodules were large, there tended to be few of them. Conversely, when the nodule count was high, they tended to be small. Figure 4 shows a typical histogram of nodule sizes produced by an image analysis

Figure 4: Example distribution of nodule sizes

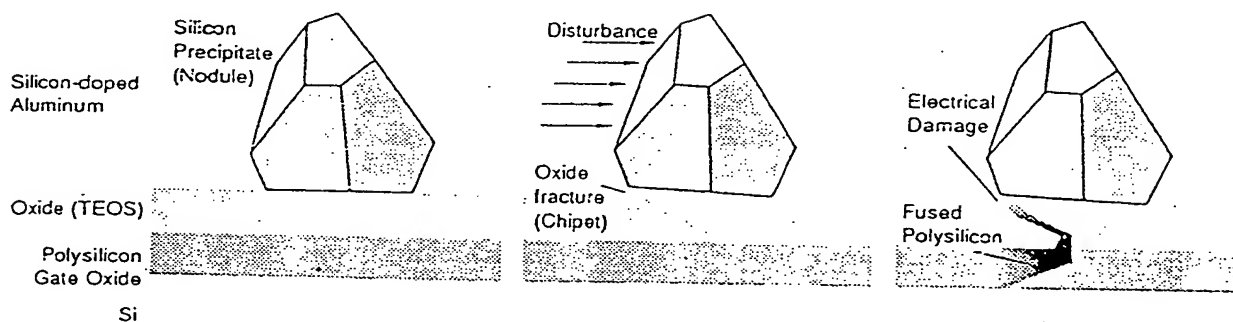
The adhered nodules could be removed quite easily; gentle brushing of a few fibers from a cotton swab was sufficient to disturb them. When these well-adhered nodules are displaced, they often take with them a portion of underlying oxide, forming a distinctive, football-shaped chip-out, or *chipet* (Figure 5). The depth of the resulting chipet was roughly equal to half the length of the chipet's minor axis, itself related to the area of contact between nodule and oxide.

Figure 5: Movement of nodule results in fracture of underlying oxide.

electrical stress, appear to act as weak points in the insulating oxide. If the chiplet is sufficiently deep to fully compromise the thickness of the dielectric oxide, a linear resistive short between the source metallization and gate polysilicon results. However, if the root only partially compromises the dielectric, a leaky diode-like characteristic results.
